RE: Annual 2014 Inspection Report Star Point Refuse Pile C/007/042

Please find enclosed a copy of the Annual 2014 Inspection Report for the Star Point refuse pile, impoundments, and excess spoil area.

Inspection Date: Dec 17, 2014

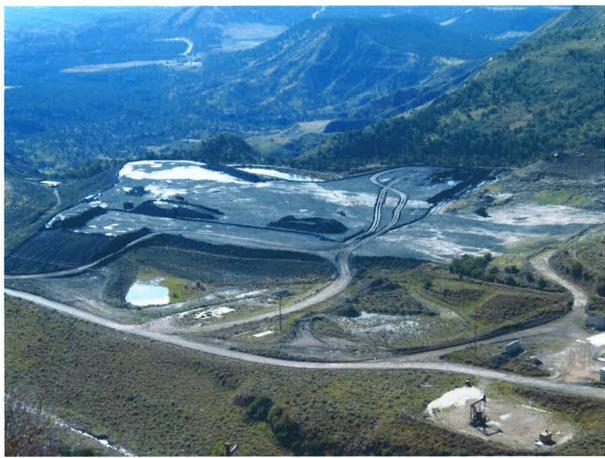
SCA- Star Point Refuse Pile and surrounding area

- Describe any changes in the geometry of the structure (as well as instrumentation, if any, used to monitor changes): <u>Refuse</u>
   material is actively being excavated and removed from locations across the top of the pile

- 9. Describe any appearances of instability, structural weakness, and other hazardous conditions No aspects of the Fill structure were observed that could affect its stability or functionality or which indicated hazardous conditions

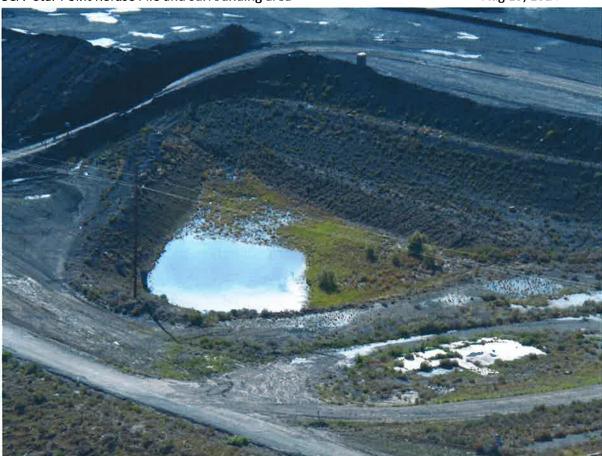
Sediment Pond 009

Pond had no water. No samples were taken. Pond did not require decanting.

Embankment conditions were good. Vegetation on outslopes was adequate.

Inlet / Outlet conditions were good. No structural or hazardous conditions were observed.

August storms caused some culverts within the Pond 009 drainage area to accumulate sediment. During an inspection, UDOGM issued NOV 12148. SCA completed an internal evaluation of culvert needs, submitted a permit amendment, cleaned ditches and removed unneeded culverts in the area. All diversions and culverts in this drainage 009 area functioned well during the late September storms experienced. DOGM approved the amendment submitted to remove unneeded culverts in December.

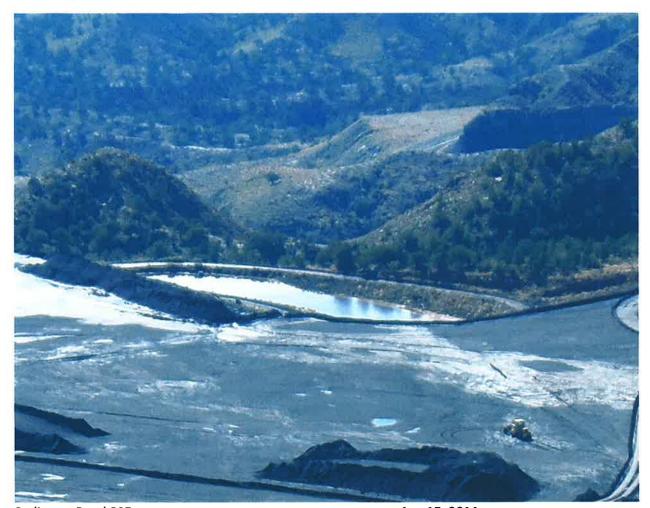
Sediment Pond 005

Pond had no water in it at time of inspection. Storms in late September caused a discharge. Samples were taken at that time and test results from that discharge are attached here.

Sediment levels were reasonably low.

Embankment conditions were good. Vegetation on outslopes was adequate.

Inlet / Outlet conditions were good. No structural or hazardous conditions were observed.

Although a discharge did occur from Pond 5 as a result of multiple storms in late September, sample analysis indicates that adequate detention time occurred and the state discharge limitations were not exceeded.
